A Case History of Microtunneling through a Very Soft Soil Condition

the Contractor's Perspective

Alan Atalah¹

Abstract- Waikiki Public Bath Force Main Replacement Project consists of 1,037 m of 400 mm force main that carries the wastewater from the Public Bath pump station to a gravity sewer on the Kuhio Avenue. This force main transports wastewater underneath Kalakaua Ave, very close to some of the most expensive real state in the world. This area is the heart of Waikiki beach, and it is full of beach resorts, five star hotels, shopping, etc. The soil strata can be described as 2.50 to 3.00 m deep of beach sand on top of half a meter of a very hard coral ledge on top of a lagoon deposit layer (very soft gray fat clay). The N_{SPT} values in this lagoon deposit layer range from zero to eight. The specified construction method for this project was microtunneling of 700 mm of Permalok steel casing with a 400 mm PVC carrier pipe inside the casing. The annular space between the two pipes was grouted with low density grout. Many problems were encountered during the construction phase of this project. This paper is a retrospective review of the project from the contractor's point of v

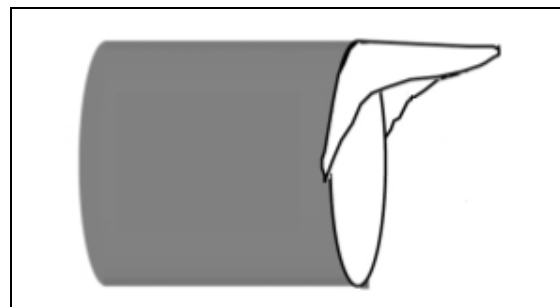
A. Arched barrel, hood, or plates (as shown in Figure 2) would increase the bearing area of the MTBM and redistribute the concentrated load at the front of the head. This solution was eliminated because the cutters would not have access to tunnel through the potentially harder material along the drive and through the receiving shaft wall. If the barrel, hood, or plate could extend and retract upon demand, this solution might have been a better solution.

Figure 2 The barrel, hood, or plates ^[6]

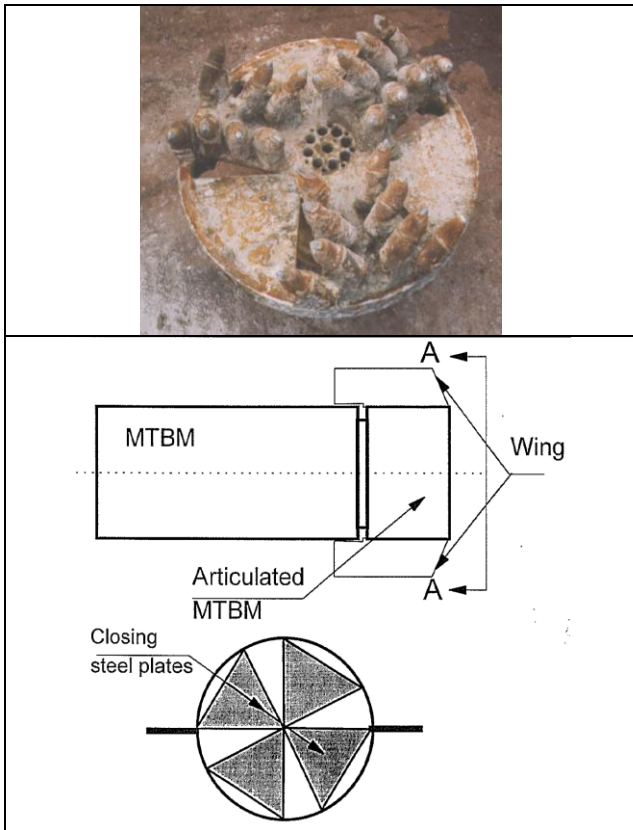
1. Welding two plates along the sides of the articulated head as shown in Figure 3 to reduce the stress on the soil. The front edges of the plates would be serrated so it can cut through the coral if encountered.

Figure 3 Wings modifications and choking the entrance of the MTBM

2. Choking the entrance to the crushing chamber as shown in Figure 3 and stop running the tunneling system.

The estimated cost for the MTBM rework amounted to approximately \$8,500. There were other related miscellaneous cost (rubber ring, larger exit and entry rings, dewatering, etc.) making the total cost about \$25,000. In addition, the estimated cost for the machine retrieval amounted to about \$35,000 excluding the cost of retrieving the head in case of failure. This solution could be executed by the contractor without the need for subcontract from outside Oahu, which would reduce the delay in completing the project. This solution had never been tried before. There was also the potential risk of encountering coral along the path of the wings.

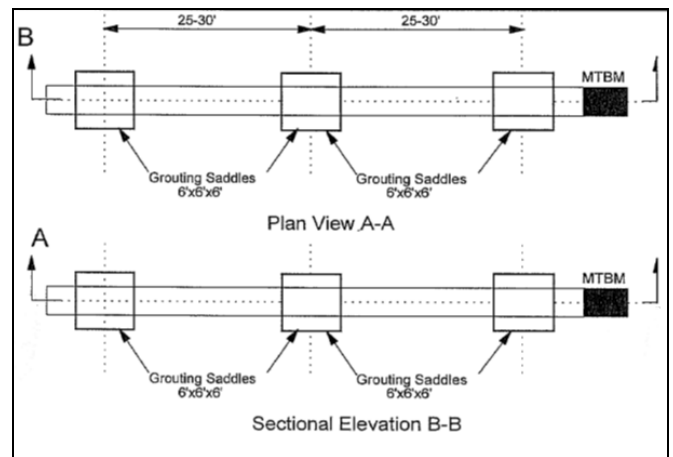
The microtunneling machine would tunnel through the upper meter of the saddle as shown in Figure 4. It would go from cube to cube without falling substantially off grade. As the MTBM tunnels through the grout block, the microtunneling machine operator would steer the head against the harder body underneath it and correct the grade. The quoted cost from the grouting subcontractor was \$100,000; the total cost was estimated to be \$125,000 after adding the cost of the machine retrieval.

Figure 4 Compaction Grout Saddles Solution

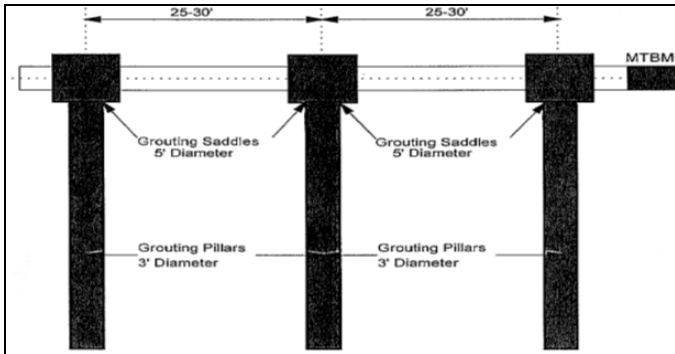
D. Compaction grout pillars solution would involve grouting 750 to 900 mm diameter pillars extending upward from the harder layer at the bottom up to one foot below the invert of the casing pipe as shown in Figure 5. The pillars would support grouted cubes similar to the grout cubes of the previously mentioned solution. The pillars and the cubes would be constructed using compaction grout. The spacing

of the pillars would be 7.5 to 10 m. The quoted cost from the grouting subcontractor was \$140,000. This solution provides more stability to the saddle by carrying the weight of the saddle and the head to a more stable soil through the pillars. The disadvantages were inconsistency of the block material, inaccuracy of the block location, dimension, and permeability, and sufficiency of the 1.5 m length to correct the grade. This solution also has never been tried before.

Figure 5 Compaction grout pillars solution

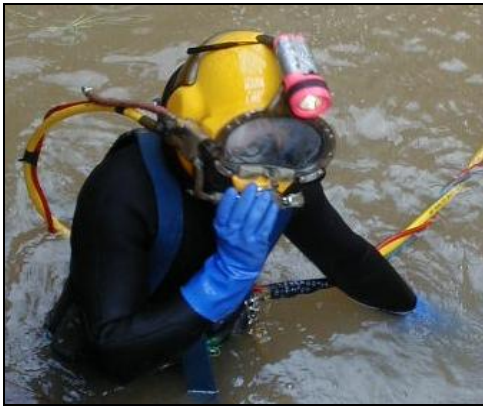
During that year, the contractor, engineer, construction manager, and the owner decided to abandon microtunneling as the installation method and install the pipe for the rest of the project using horizontal directional drilling. The MTBM was retrieved after digging a rescue shaft using divers to disconnect it below the ground water table as shown in Figure 7. The rest of the job was completed successfully using Horizontal Directional Drilling (HDD) without any significant problems and with minimum impact on the businesses, hotels, and traffic as shown in Figure 8.

Figure 7 Retrieving the MTBM
