## Case History of Microtunneling through a Very Soft Soil Condition

# A Case History of Microtunneling through a Very Soft Soil Condition

the Contractor's Perspective

**Abstract-** Waikiki Public Bath Force Main Replacement Project consists of 1,037 m of 400 mm force main that carries the wastewater from the Public Bath pump station to a gravity sewer on the Kuhio Avenue. This force main transports wastewater underneath Kalakaua Ave, very close to some of the most expensive real state in the world. This area is the heart of Waikiki beach, and it is full of beach resorts, five star hotels, shopping, etc. The soil strata can be described as 2.50 to 3.00 m deep of beach sand on top of half a meter of a very hard coral ledge on top of a lagoon deposit layer (very soft gray fat clay). The  $N_{SPT}$  values in this lagoon deposit layer range from zero to eight. The specified construction method for this project was microtunneling of 700 mm of Permalok steel casing with a 400 mm PVC carrier pipe inside the casing. The annular space between the two pipes was grouted with low density grout. Many problems were encountered during the construction phase of this project. This paper is a re

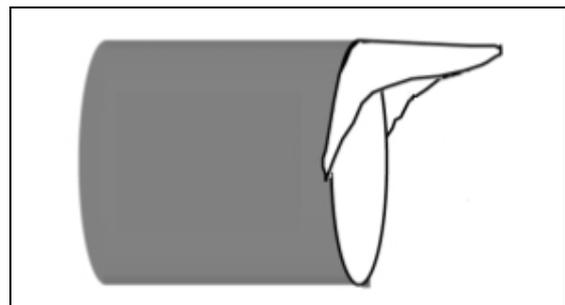
Figure 2 The barrel, hood, or plates <sup>[6]</sup>

A. Arched barrel, hood, or plates (as shown in Figure 2) would increase the bearing area of the MTBM and redistribute the concentrated load at the front of the head. This solution was eliminated because the cutters would not have access to tunnel through the potentially harder material along the drive and through the receiving shaft wall. If the barrel, hood, or plate could extend and retract upon demand, this solution might have been a better solution.

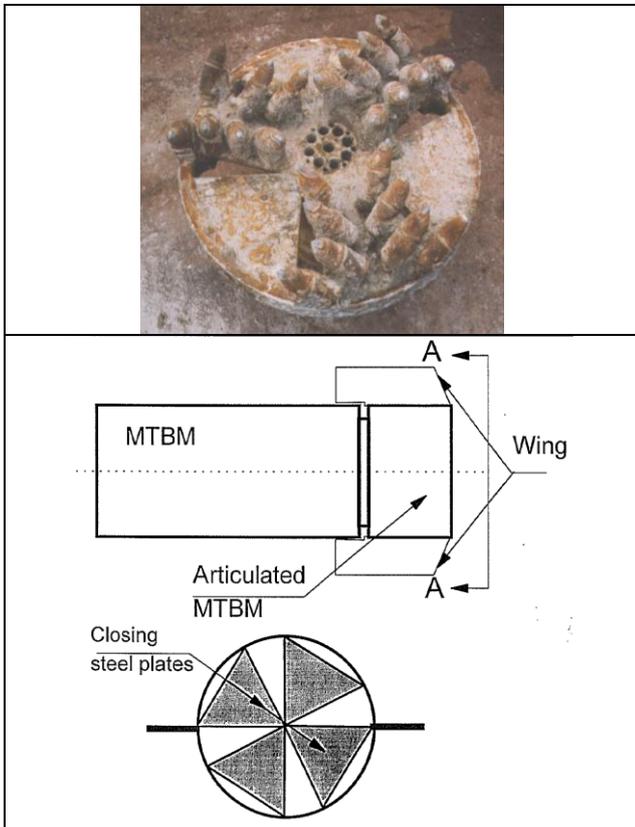
Figure 3 Wings modifications and choking the entrance of the MTBM

The estimated cost for the MTBM rework amounted to approximately \$8,500. There were other related miscellaneous cost (rubber ring, larger exit and entry rings, dewatering, etc.) making the total cost about \$25,000. In addition, the estimated cost for the machine retrieval amounted to about \$35,000 excluding the cost of retrieving the head in case of failure. This solution could be executed by the contractor without the need for subcontract from outside Oahu, which would reduce the delay in completing the project. This solution had never been tried before. There was also the potential risk of encountering coral along the path of the wings.

1. Welding two plates along the sides of the articulated head as shown in Figure 3 to reduce the stress on the soil. The front edges of the plates would be serrated so it can cut through the coral if encountered.

2. Choking the entrance to the crushing chamber as shown in Figure 3 and stop running the tunneling system.

3. Orienting the MTBM slightly upward to compensate for potential settlement

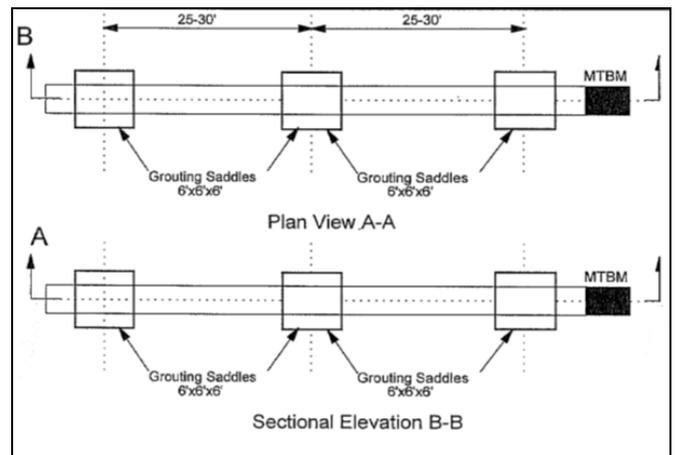
Figure 4 Compaction Grout Saddles Solution

The grout would be injected as a homogeneous mass with a distinct interface between the grout and soil. It would move into the weakest zones creating an irregularly shaped matrix of soil. Advantages were minimum site disturbance and risk, flexibility of scope, economy, applicability where the groundwater surface is high, and ability to lift settled structures to proper grade [7]. Compaction grouting is a proven method of stabilizing fine grain soils, but it has experienced a mixed history; technical success and cost control remain difficult to predict. It depends mainly on the permeability of the ground requiring stabilization [8]. The associated risks with this solution were the settlement and stability of the block, inconsistency of the block material, location, dimension, and permeability. It was uncertain if the 1.5 m length to the grouted block would be sufficient to correct the grade. Additional disadvantages were: limited number of suppliers, a long waiting time to procure a contract and to transport the required equipment to the Oahu, the risk of over spilling on the streets and sidewalks, which was not acceptable in Waikiki, and the experimental nature of the compaction grout in that microtunneling application.

**C.** Compaction grout saddles would involve building a 1.50 m x 1.50 m x 1.50 m grout cube every 8 m on center. Compaction grouting is the injection of a very stiff and low slump grout under relatively high pressure to displace and compact soils in place. The grout usually

The microtunneling machine would tunnel through the upper meter of the saddle as shown in Figure 4. It would go from cube to cube without falling substantially off grade. As the MTBM tunnels through the grout block, the microtunneling machine operator would steer the head against the harder body underneath it and correct the grade. The quoted cost from the grouting subcontractor was \$100,000; the total cost was estimated to be \$125,000 after adding the cost of the machine retrieval.

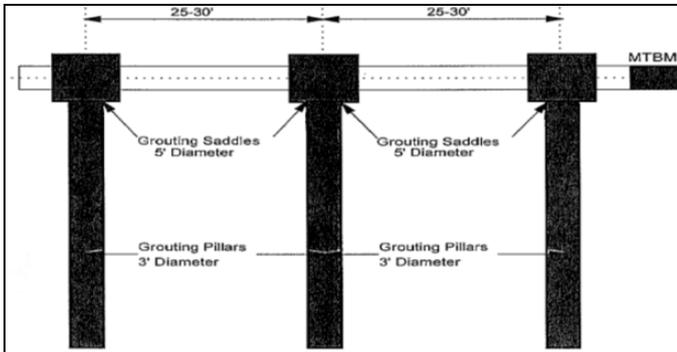
Figure 5 Compaction grout pillars solution

of the pillars would be 7.5 to 10 m. The quoted cost from the grouting subcontractor was \$140,000. This solution provides more stability to the saddle by carrying the weight of the saddle and the head to a more stable soil through the pillars. The disadvantages were inconsistency of the block material, inaccuracy of the block location, dimension, and permeability, and sufficiency of the 1.5 m length to correct the grade. This solution also has never been tried before.

**D.** Compaction grout pillars solution would involve grouting 750 to 900 mm diameter pillars extending upward from the harder layer at the bottom up to one foot below the invert of the casing pipe as shown in Figure 5. The pillars would support grouted cubes similar to the grout cubes of the previously mentioned solution. The pillars and the cubes would be constructed using compaction grout. The spacing

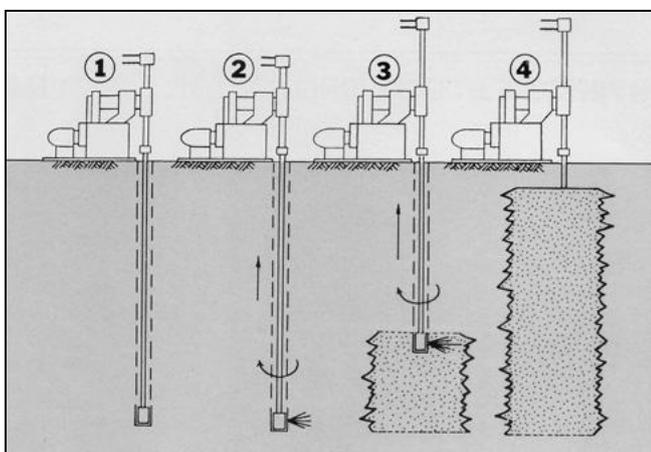
Figure 6 Jet Grouting procedures [10]

This solution was the most reliable solution; it had successful history in similar conditions. The disadvantages of this solution were high cost, limited number of suppliers, and a long waiting time to procure a contract and to transport the required equipment to Oahu. In addition, there was a risk of over spilling on the streets and sidewalks, which was not acceptable in Waikiki.

In jet grouting, the soil structure is destroyed using high energy erosive jets while simultaneously mixing grout with the disturbed soil particles in situ [8]. The jet grouting technique begins by drilling a hole; then, water jet, and in some cases an air jet, is activated. The drill rod, with the jet at the end, is rotated and withdrawn upward at a controlled rate pumping cement grout through the end of the drill stem. This process creates a roughly cylindrical column of mixed soil and cement as shown in Figure 6 [9].

JGP work sequence:	
1	Drill down to required depth;
2	High pressure cement milk emerges from the nozzle;
3	As drilling rod rotates and withdrawn, the cement milk mixes the soil
4	Cement ground column is formed

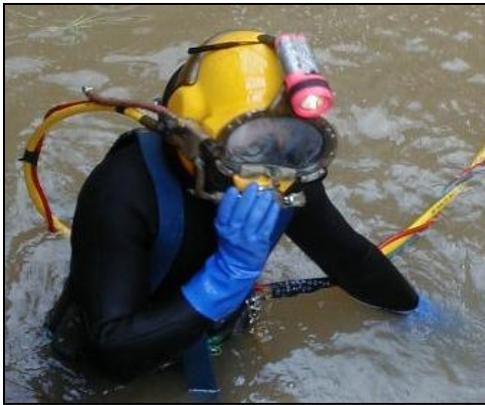
Figure 7 Retrieving the MTBM

After retrieving and checking the MTBM to ensure that everything was working properly, the MTBM was launched for the next drive (from the intersection of Paoakalani Avenue and Kalakaua Avenue towards Ohua Avenue). After about 20 m, the MTBM deviated significantly downward. At this point, construction was halted for more than a year to find alternative solution.

During that year, the contractor, engineer, construction manager, and the owner decided to abandon microtunneling as the installation method and install the pipe for the rest of the project using horizontal directional drilling. The MTBM was retrieved after digging a rescue shaft using divers to disconnect it below the ground water table as shown in Figure 7. The rest of the job was completed successfully using Horizontal Directional Drilling (HDD) without any significant problems and with minimum impact on the businesses, hotels, and traffic as shown in Figure 8.
